MEMORANDUM

October 5, 2016

SUBJECT: Public hearing and consideration of a demolition permit application for the house located at 2334 14th St., a non-landmarked building over 50 years old, pursuant to Section 9-11-23 of the Boulder Revised Code (HIS2016-00191).

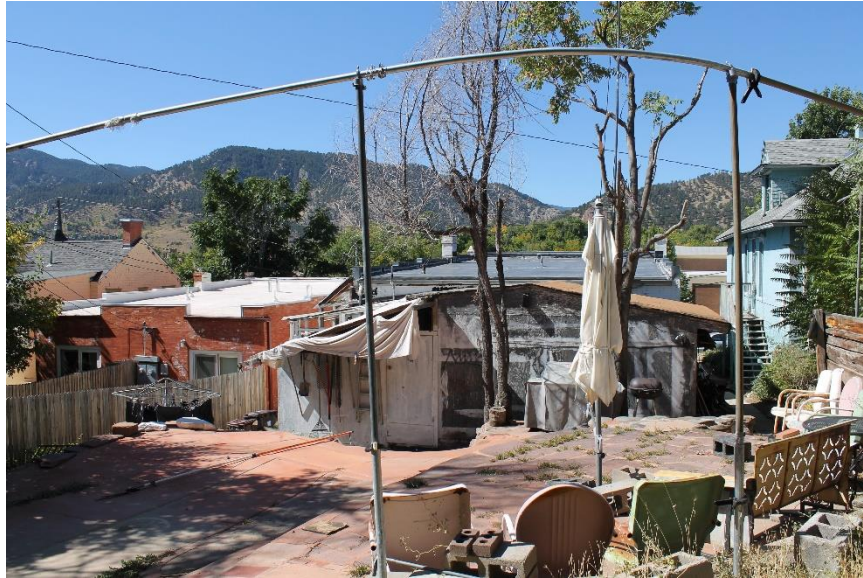
Figure 3. East Elevation (rear), 2334 14th St., 2016.

The northeast (rear) elevation is covered by a deteriorating wooden frame addition, that is partially roofed with translucent plastic sheathing. The addition wraps approximately 26' along the southeast (side) elevation of the original brick building, forming a covered porch. The side door of the southeast unit opens into this porch, and this unit also has a door at its rear opening into the shed.

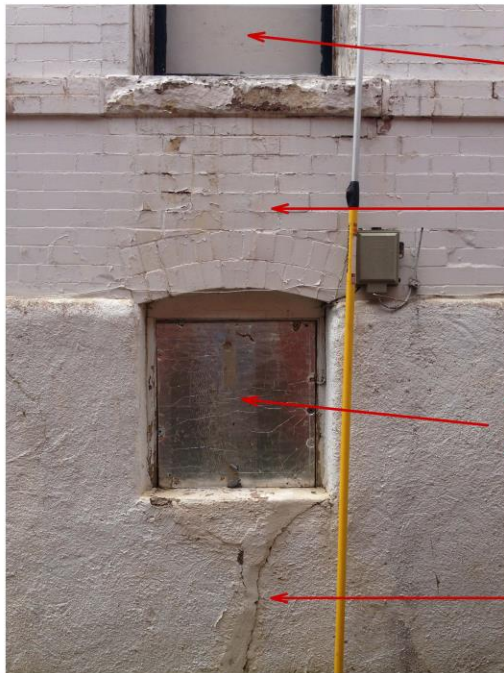
photo 7: windows

original window
is missing

foundation
failure

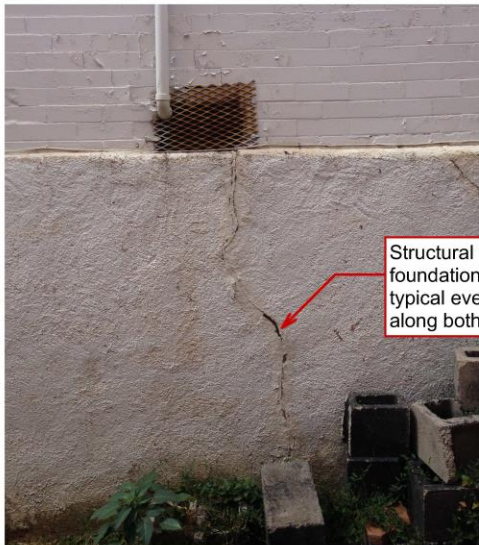
photo 9: foundation

Structural failure of exist.
foundation wall. This is
typical every 4-5 feet
along both South & North

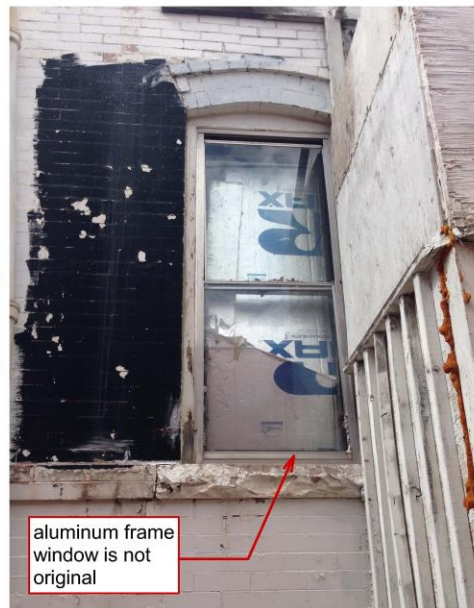
photo 10: window

aluminum frame
window is not
original

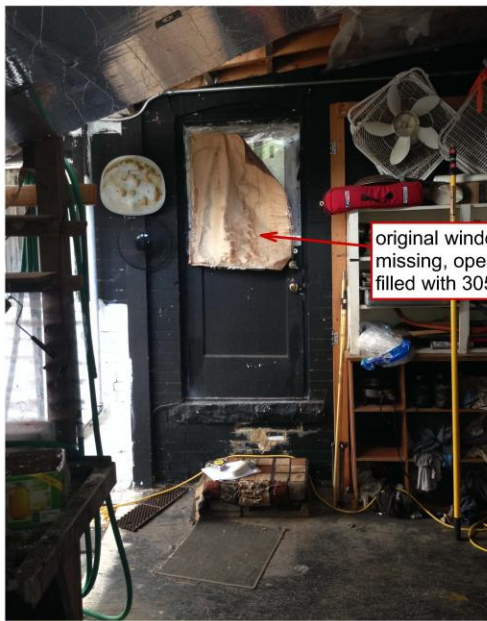
photo 15: window opening

original window
missing, opening
filled with 3050 door

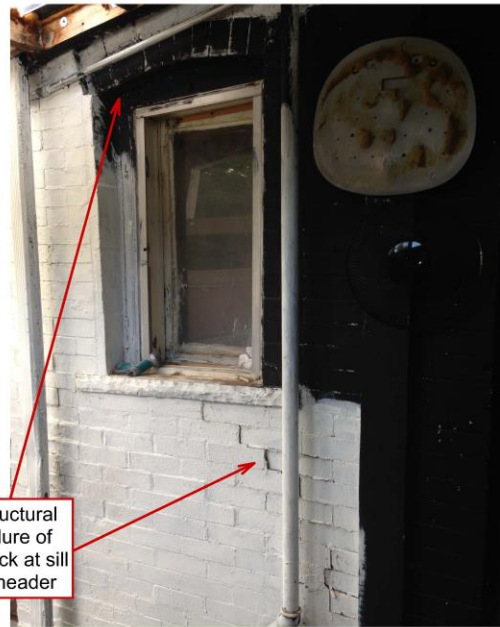
photo 16: window opening

structural
failure of
brick at sill
& header

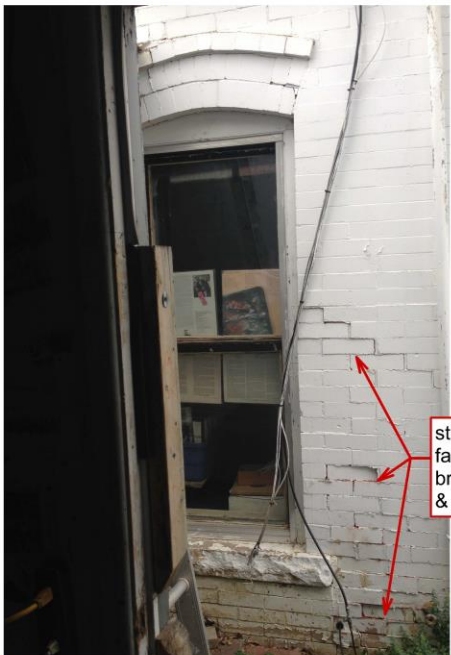
photo 17: window opening

structural
failure of
brick at sill
& fnd below

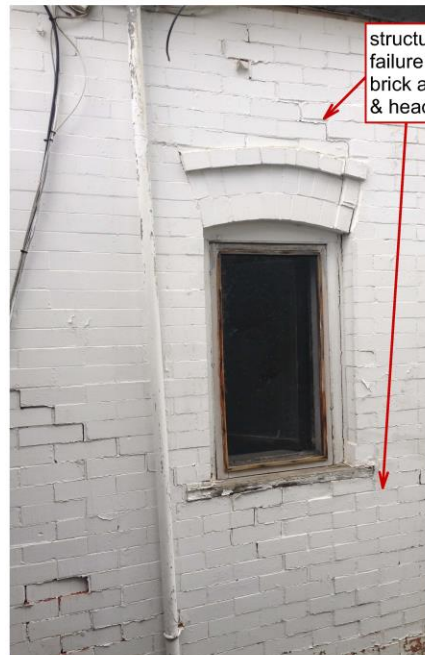
photo 18: window opening

structural
failure of
brick at sill
& header

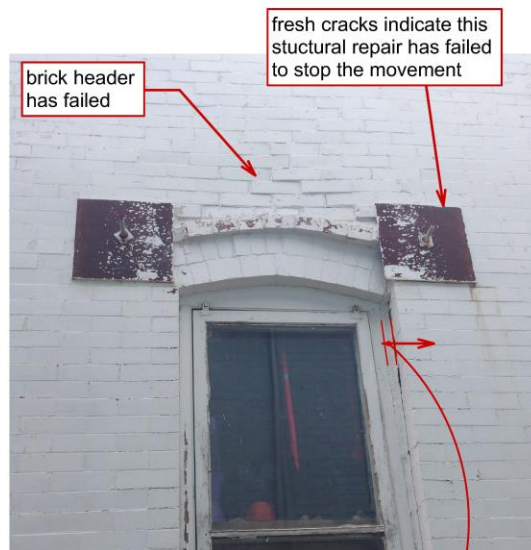
photo 23: window

This corner of the building is leaning outward. Note the 2" gap where the brick has moved away from window frame, this gap extends all the way to the interior.

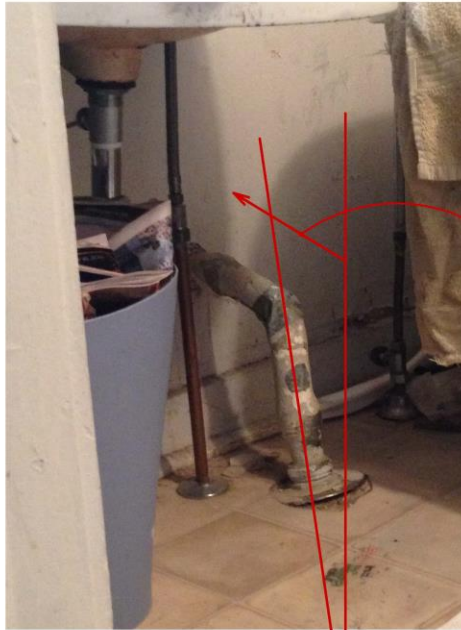
photo 24: broken drain

over 8" lateral shift

This photo shows how lateral movement of the building has caused existing drains to fail. The building has moved horizontally over 8" so that drain lines no longer align with penetrations below. The resulting stress has ripped the pipe from the floor. This damage is typical at ALL mechanical the penetrations into the lower floor or crawl space.
